Manhole Inspection Summary

Manhole # S37SS_032MH

Location Address: **2700 REESE ST**

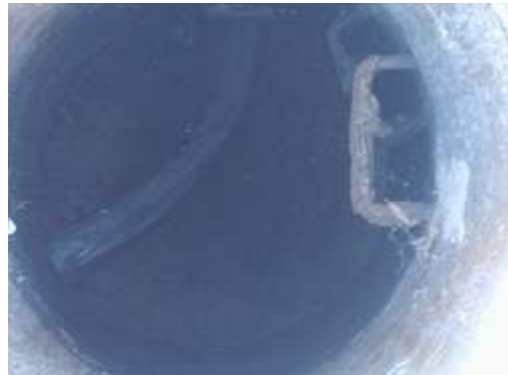
Top View

Corroded steps. Adjustment and Barrel infiltration. Bench debris.

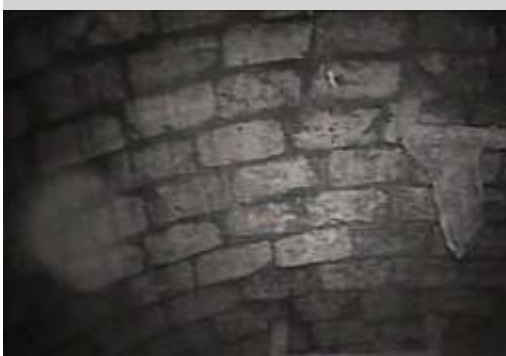
Defect

Evidence of surcharge.

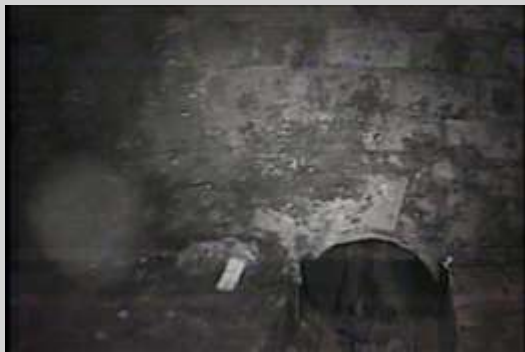
8 in. Circular Gravity Sewer Pipe Out @ 12 O'Clock

Invert Depth: **10.75** (ft.) Flow Characteristics: **Slow**

Infiltration: **None** Pipe Seal Cond: **Unknown**

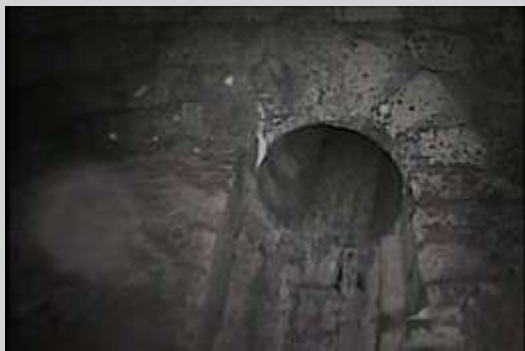
8 in. Circular Gravity Sewer Pipe In @ 7 O'Clock

Invert Depth: **10.13** (ft.) Flow Characteristics: **Slow**

Infiltration: **Evidence** Pipe Seal Cond: **Unknown**
